**Draft Closeout Report  
for IHSS Group 000-5  
(Present Landfill [IHSS 114])**

**June 22, 2005**

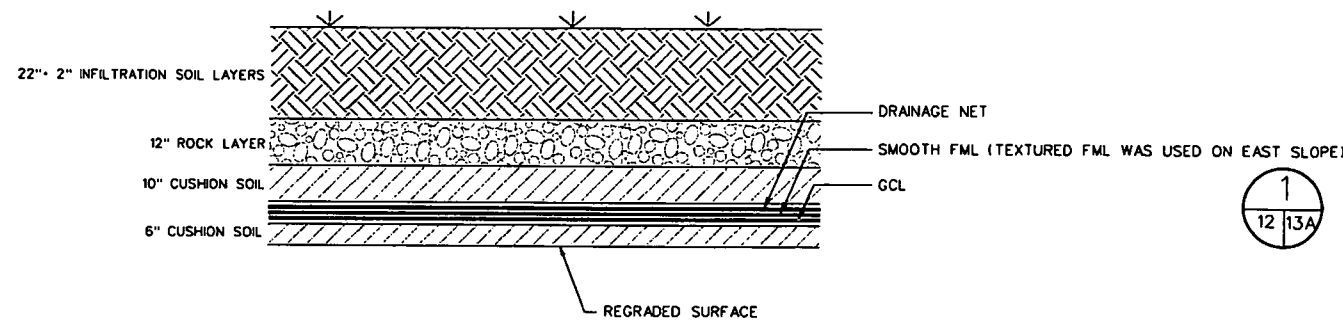
**GEOSYNTHETIC COMPOSITE FINAL COVER**  
NTS

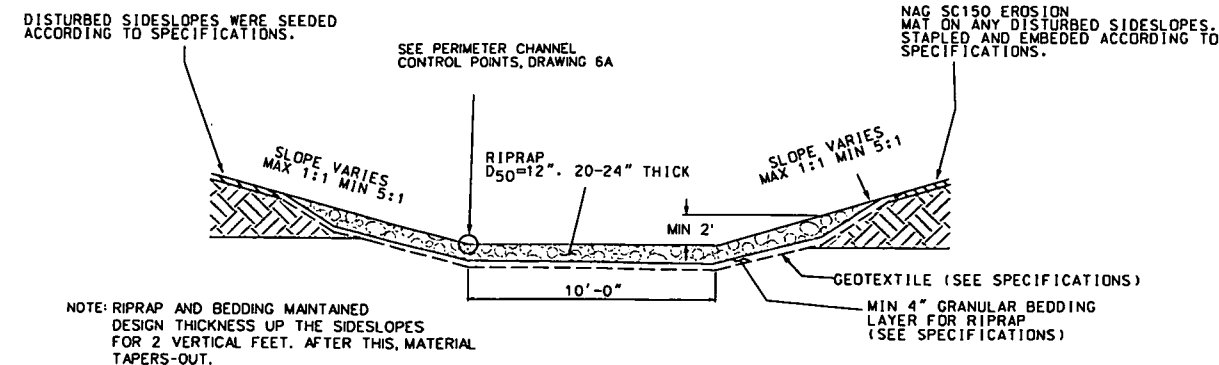
**RIPRAP LINED CHANNEL DETAIL**  
NTS

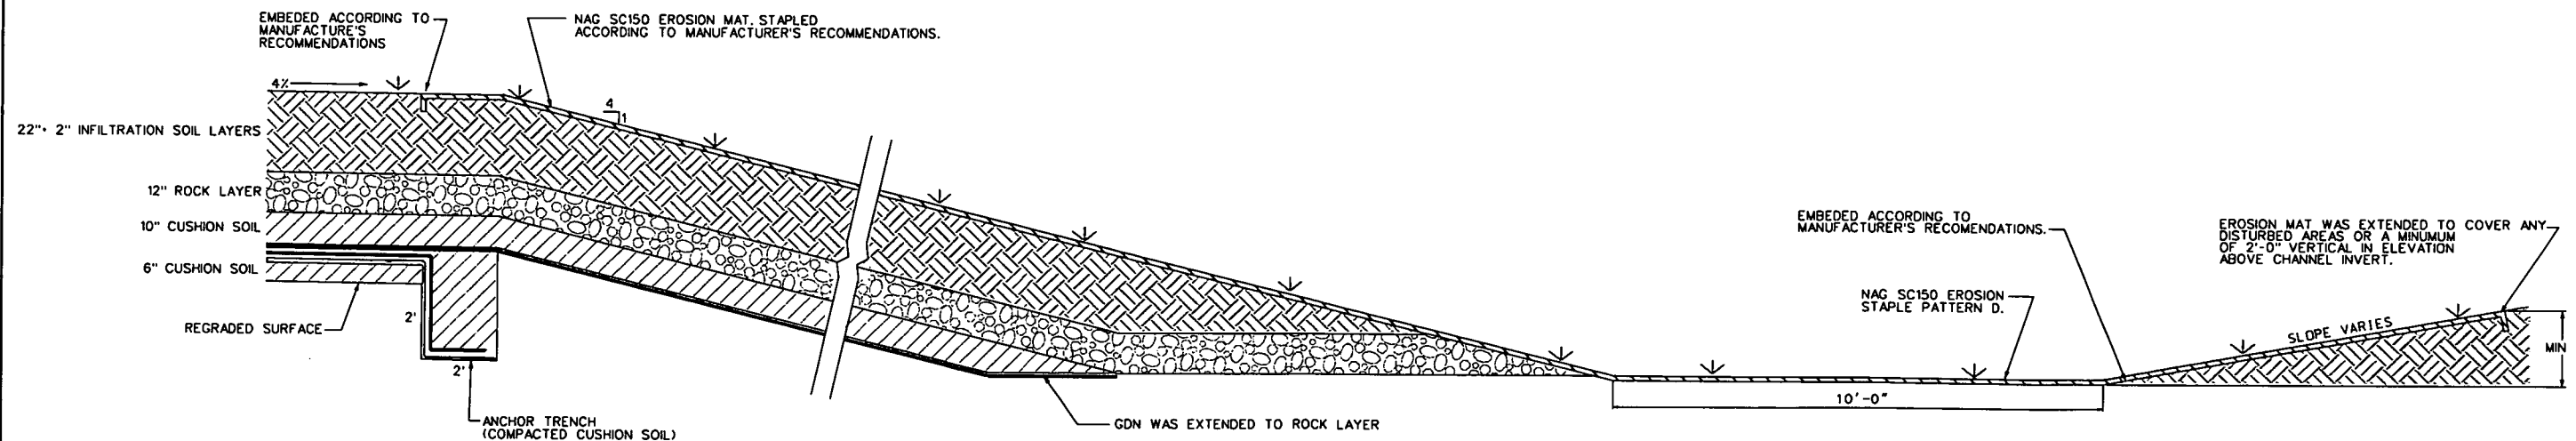
**ANCHOR TRENCH \***  
NTS

\* NOTE: WHEREVER WASTE WAS ENCOUNTERED DURING THE EXCAVATION OF THE ANCHOR TRENCH, WASTE MATERIAL WAS OVER EXCAVATED AN ADDITIONAL 1-FOOT. OVER EXCAVATIONS WERE FILLED WITH CUSHION LAYER SOIL TO THE DESIGN DIMENSIONS OF ANCHOR TRENCH.

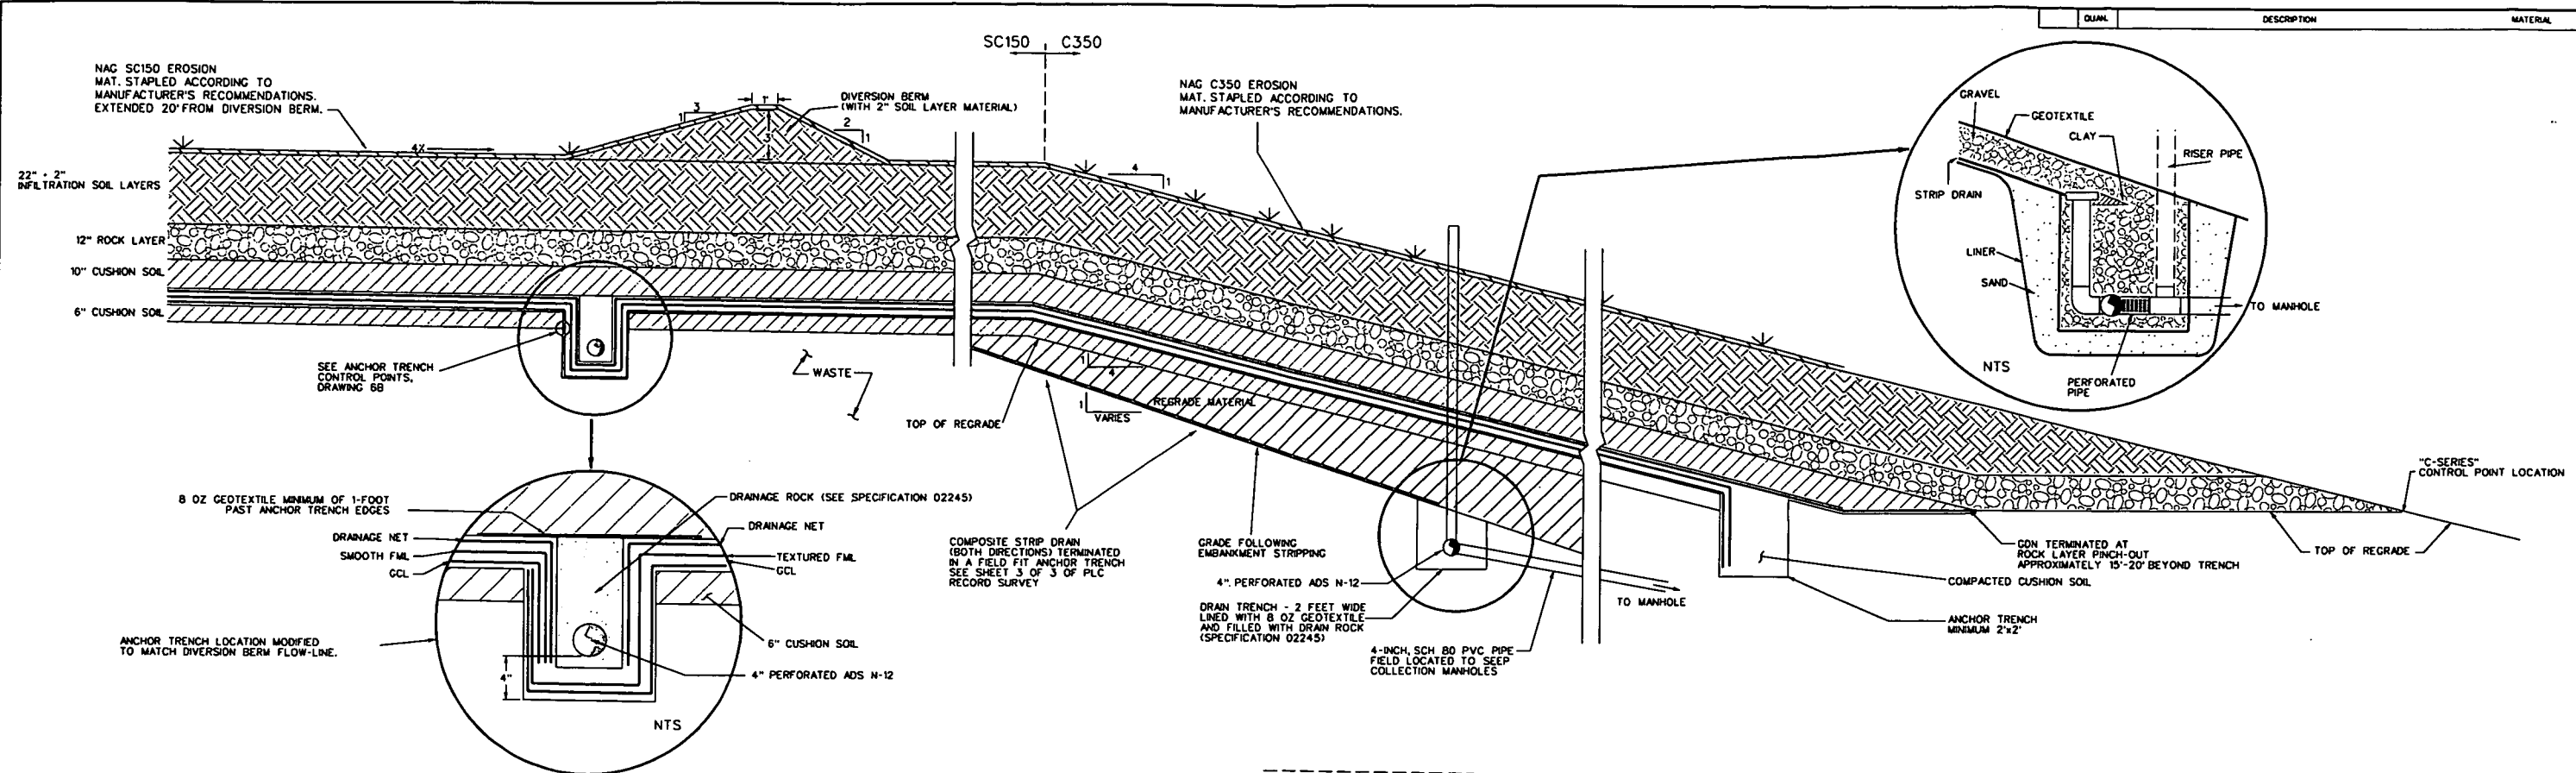
# EAST SLOPE COVER BREAK AND DIVERSION BERM

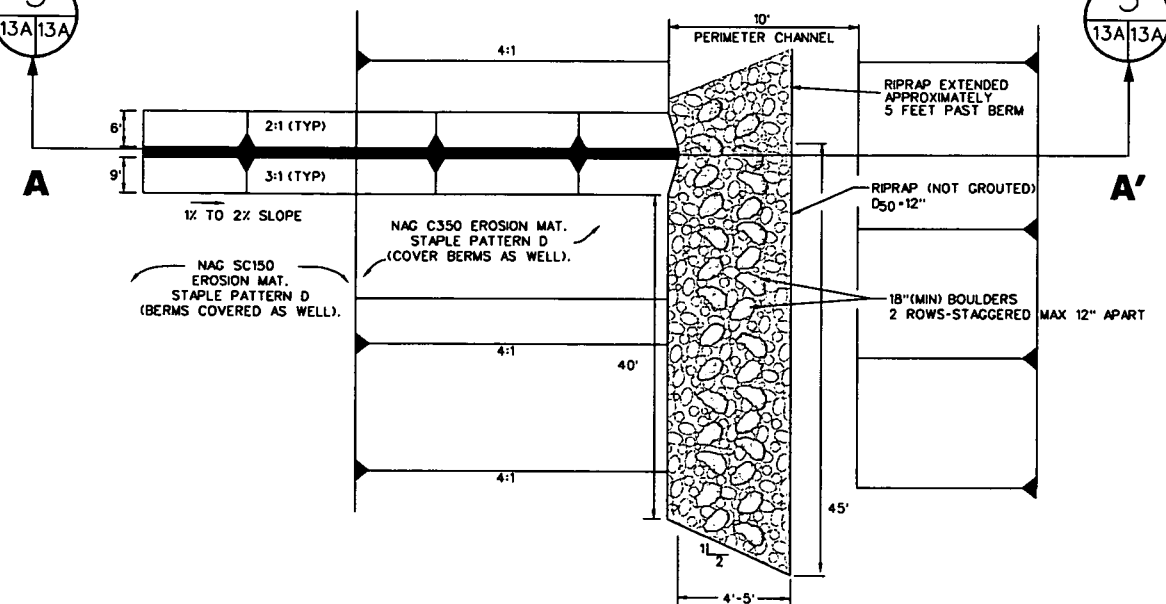
# DOWNSLOPE CHANNEL TRANSITION FROM EAST SLOPE BERM TO PERIMETER CHANNEL

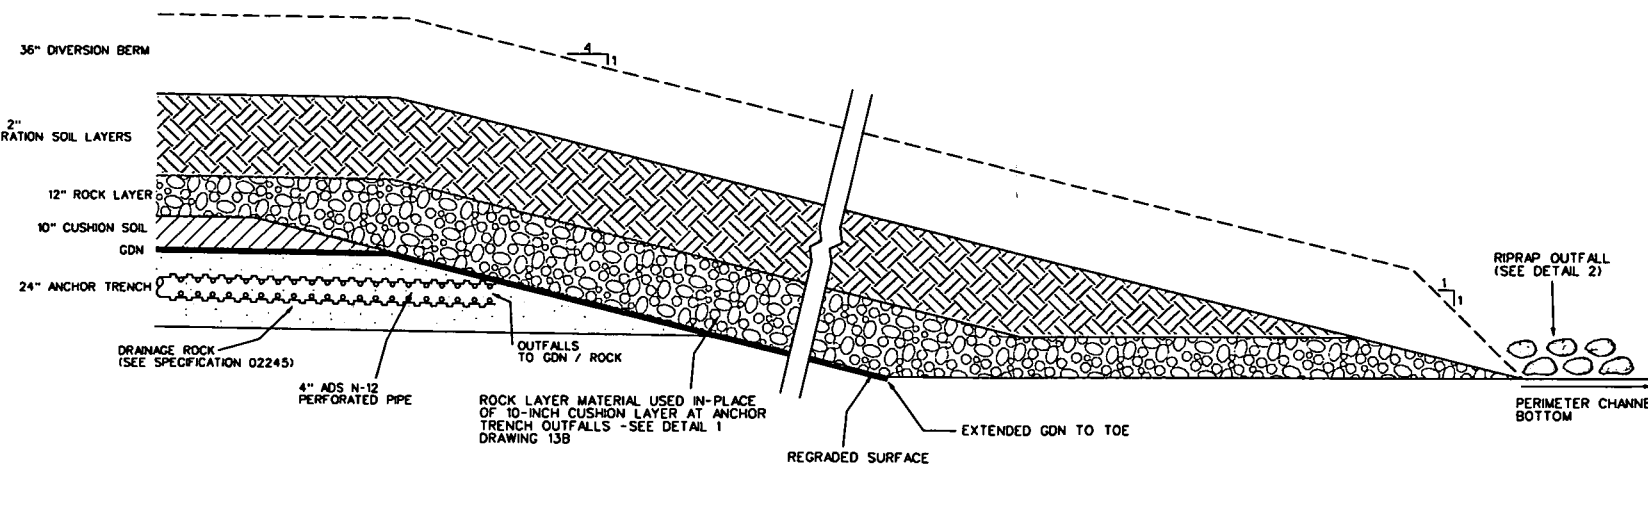
# CROSS-SECTION A - A'

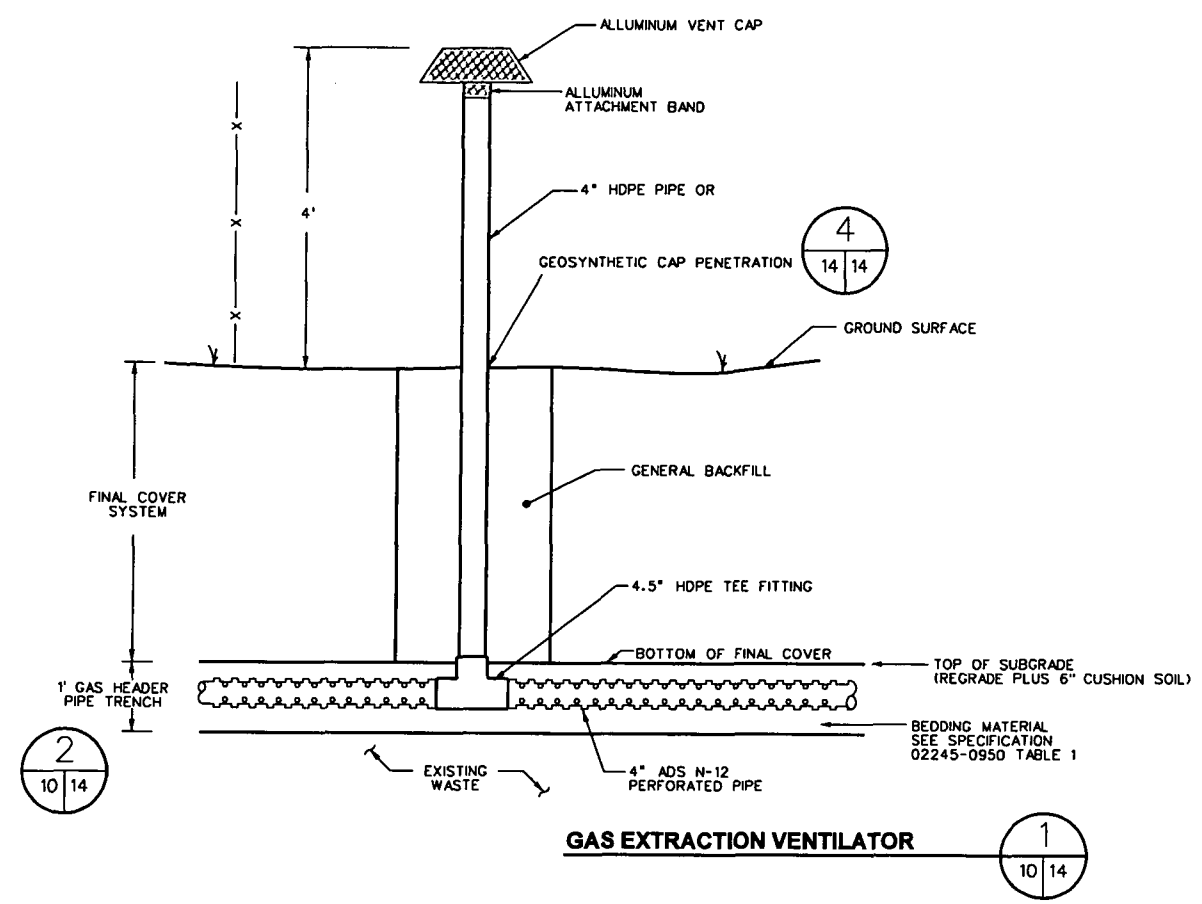
**GAS EXTRACTION VENTILATOR**

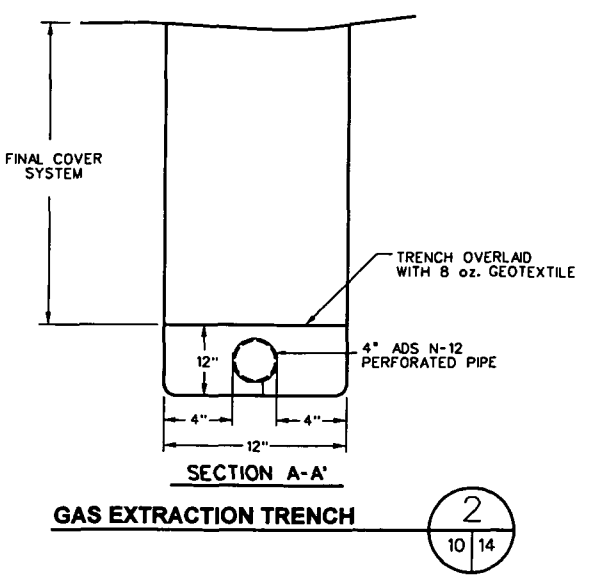
**GAS EXTRACTION TRENCH**

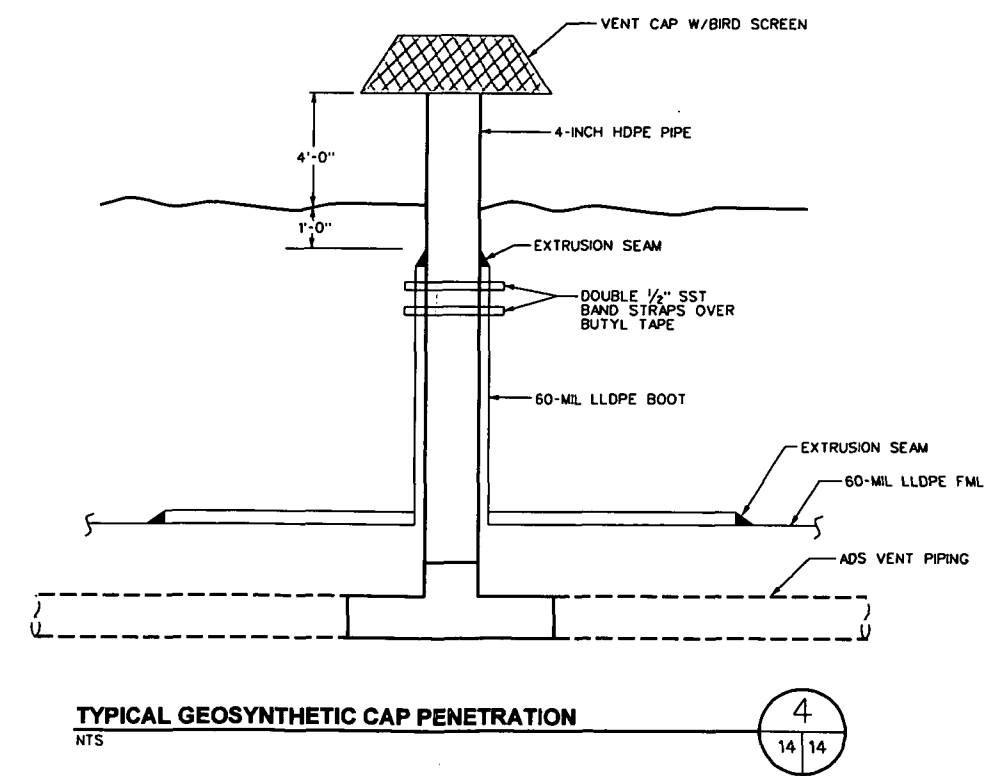
**TYPICAL GEOSYNTHETIC CAP PENETRATION**

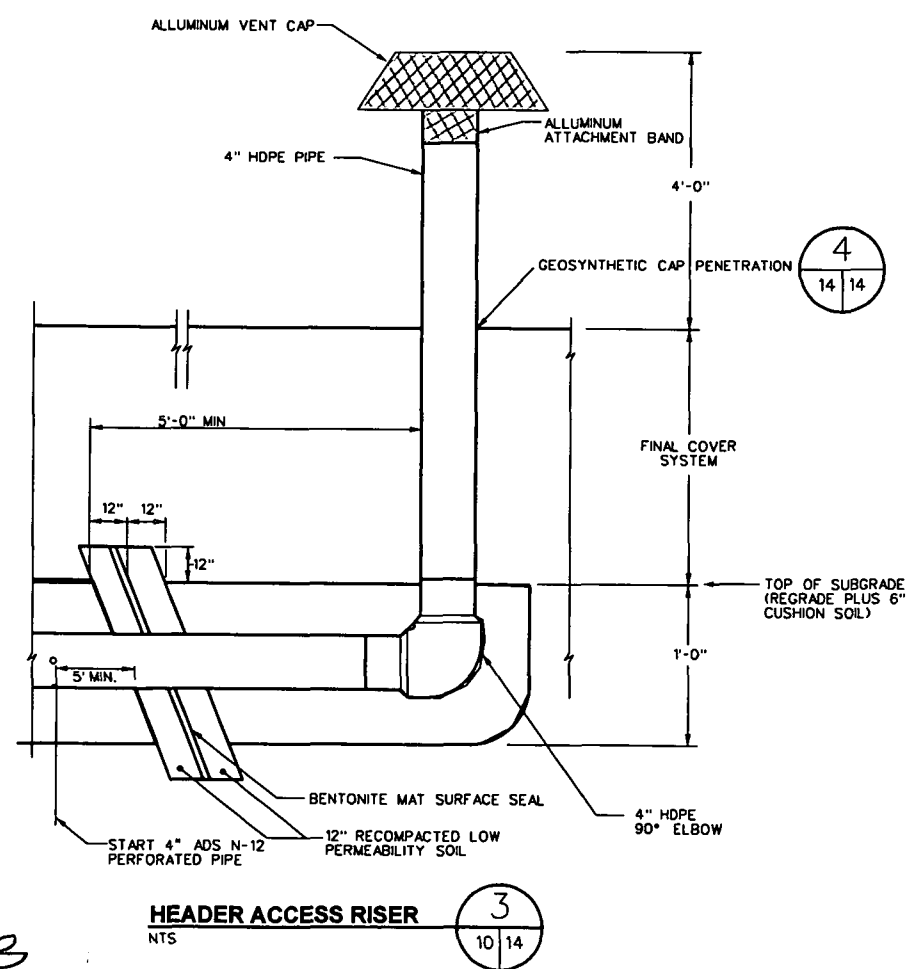
**HEADER ACCESS RISER**

1. ALL HDPE PIPE IS SDR-11 AND ALL HDPE FITTINGS ARE SDR-11 EXCEPT AS NOTED.
2. CLEAN SAND BEDDING AND BACKFILL WERE COMPACTED IN MAXIMUM LIFTS OF 9\"

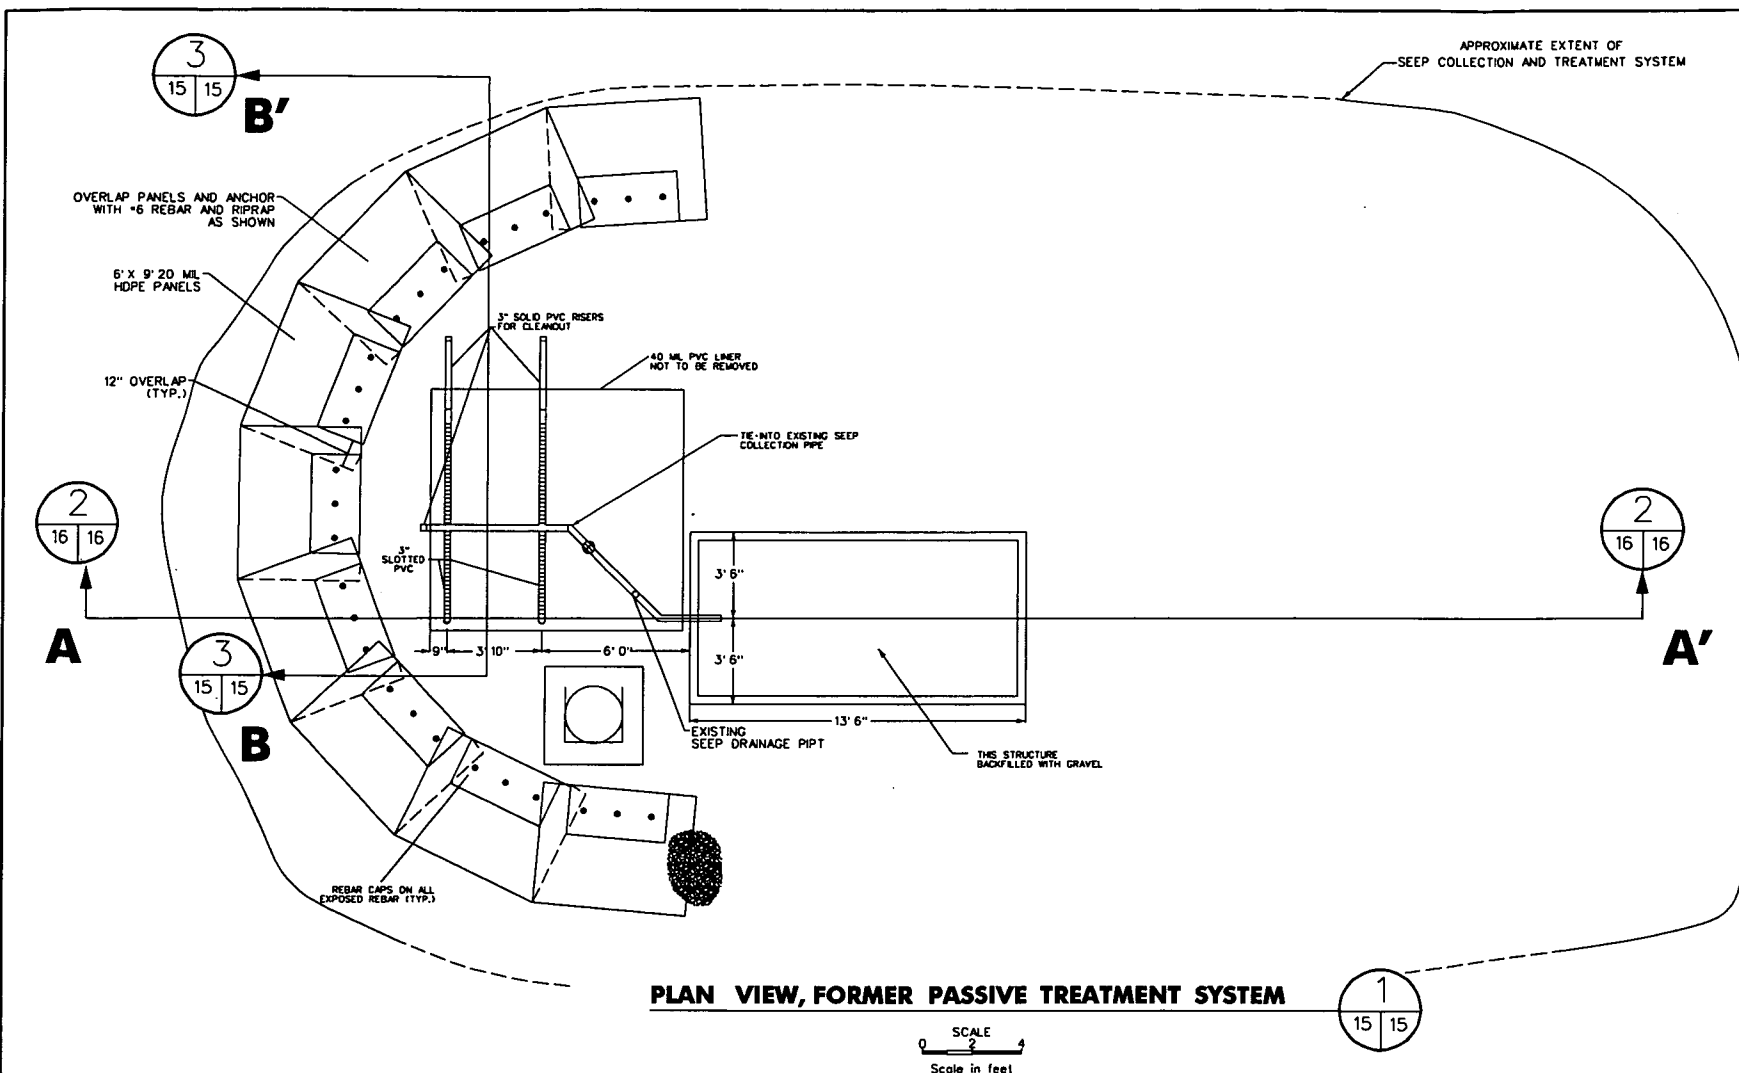
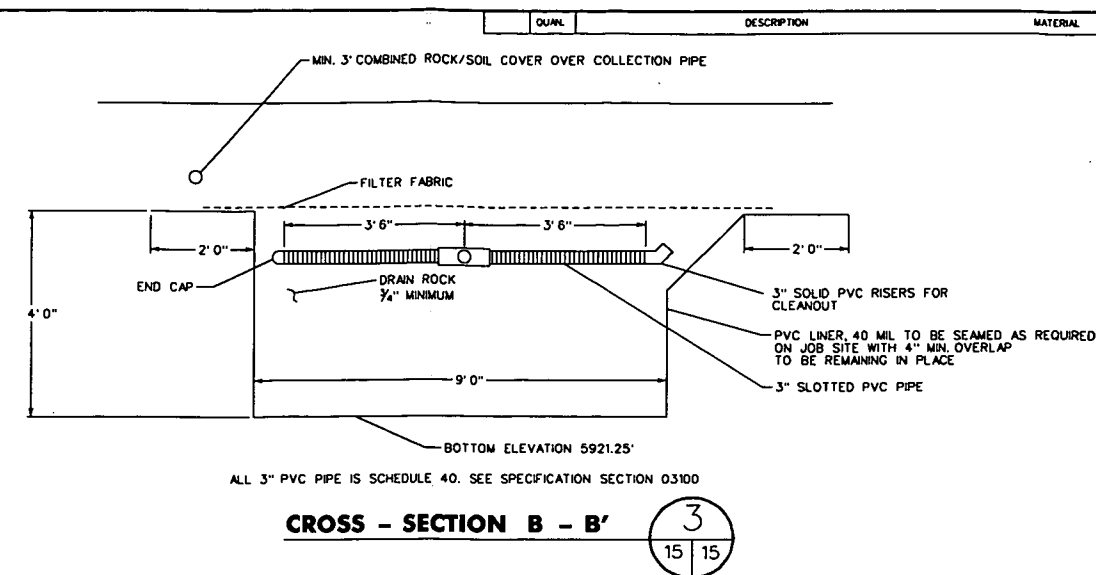
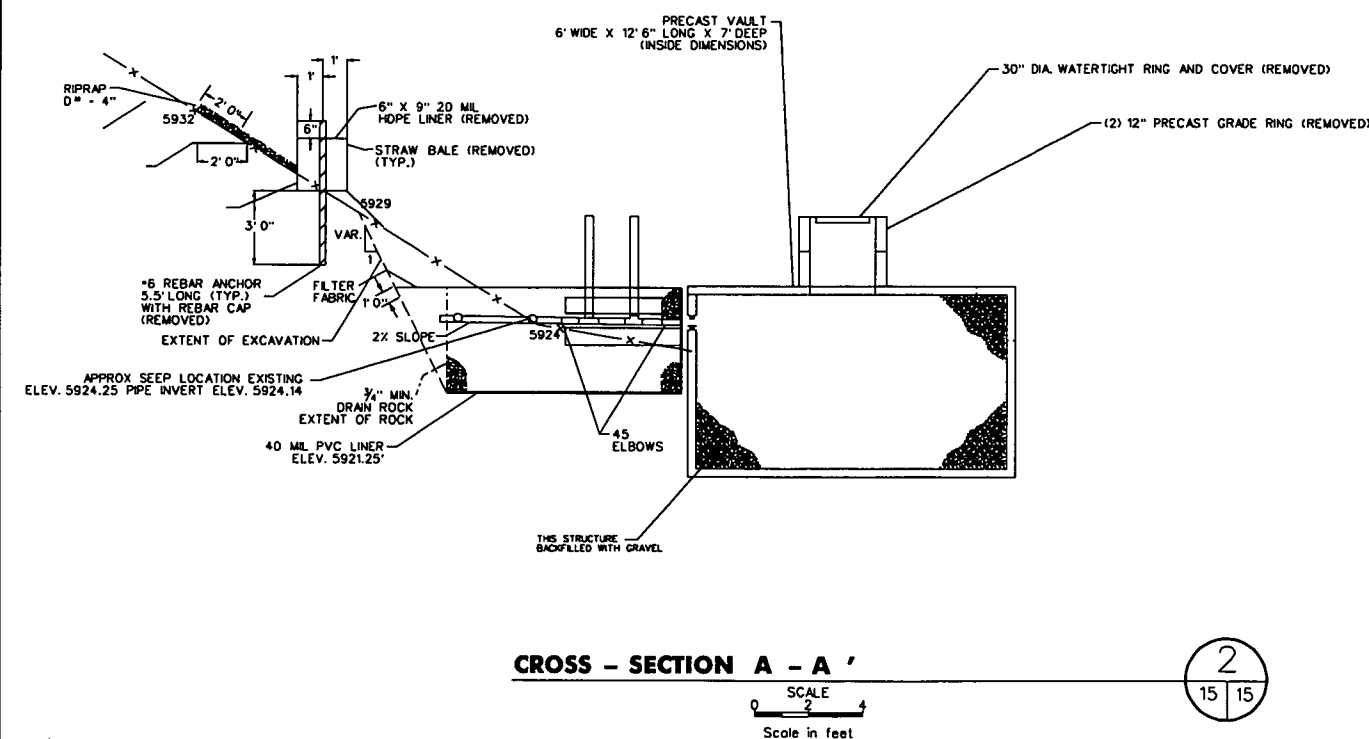
NOTE: PORTIONS OF PREVIOUS SEEP SYSTEM WERE REMOVED AND REPLACED BY NEW SEEP COLLECTION AND TREATMENT SYSTEM. SEE DRAWING 016-018.

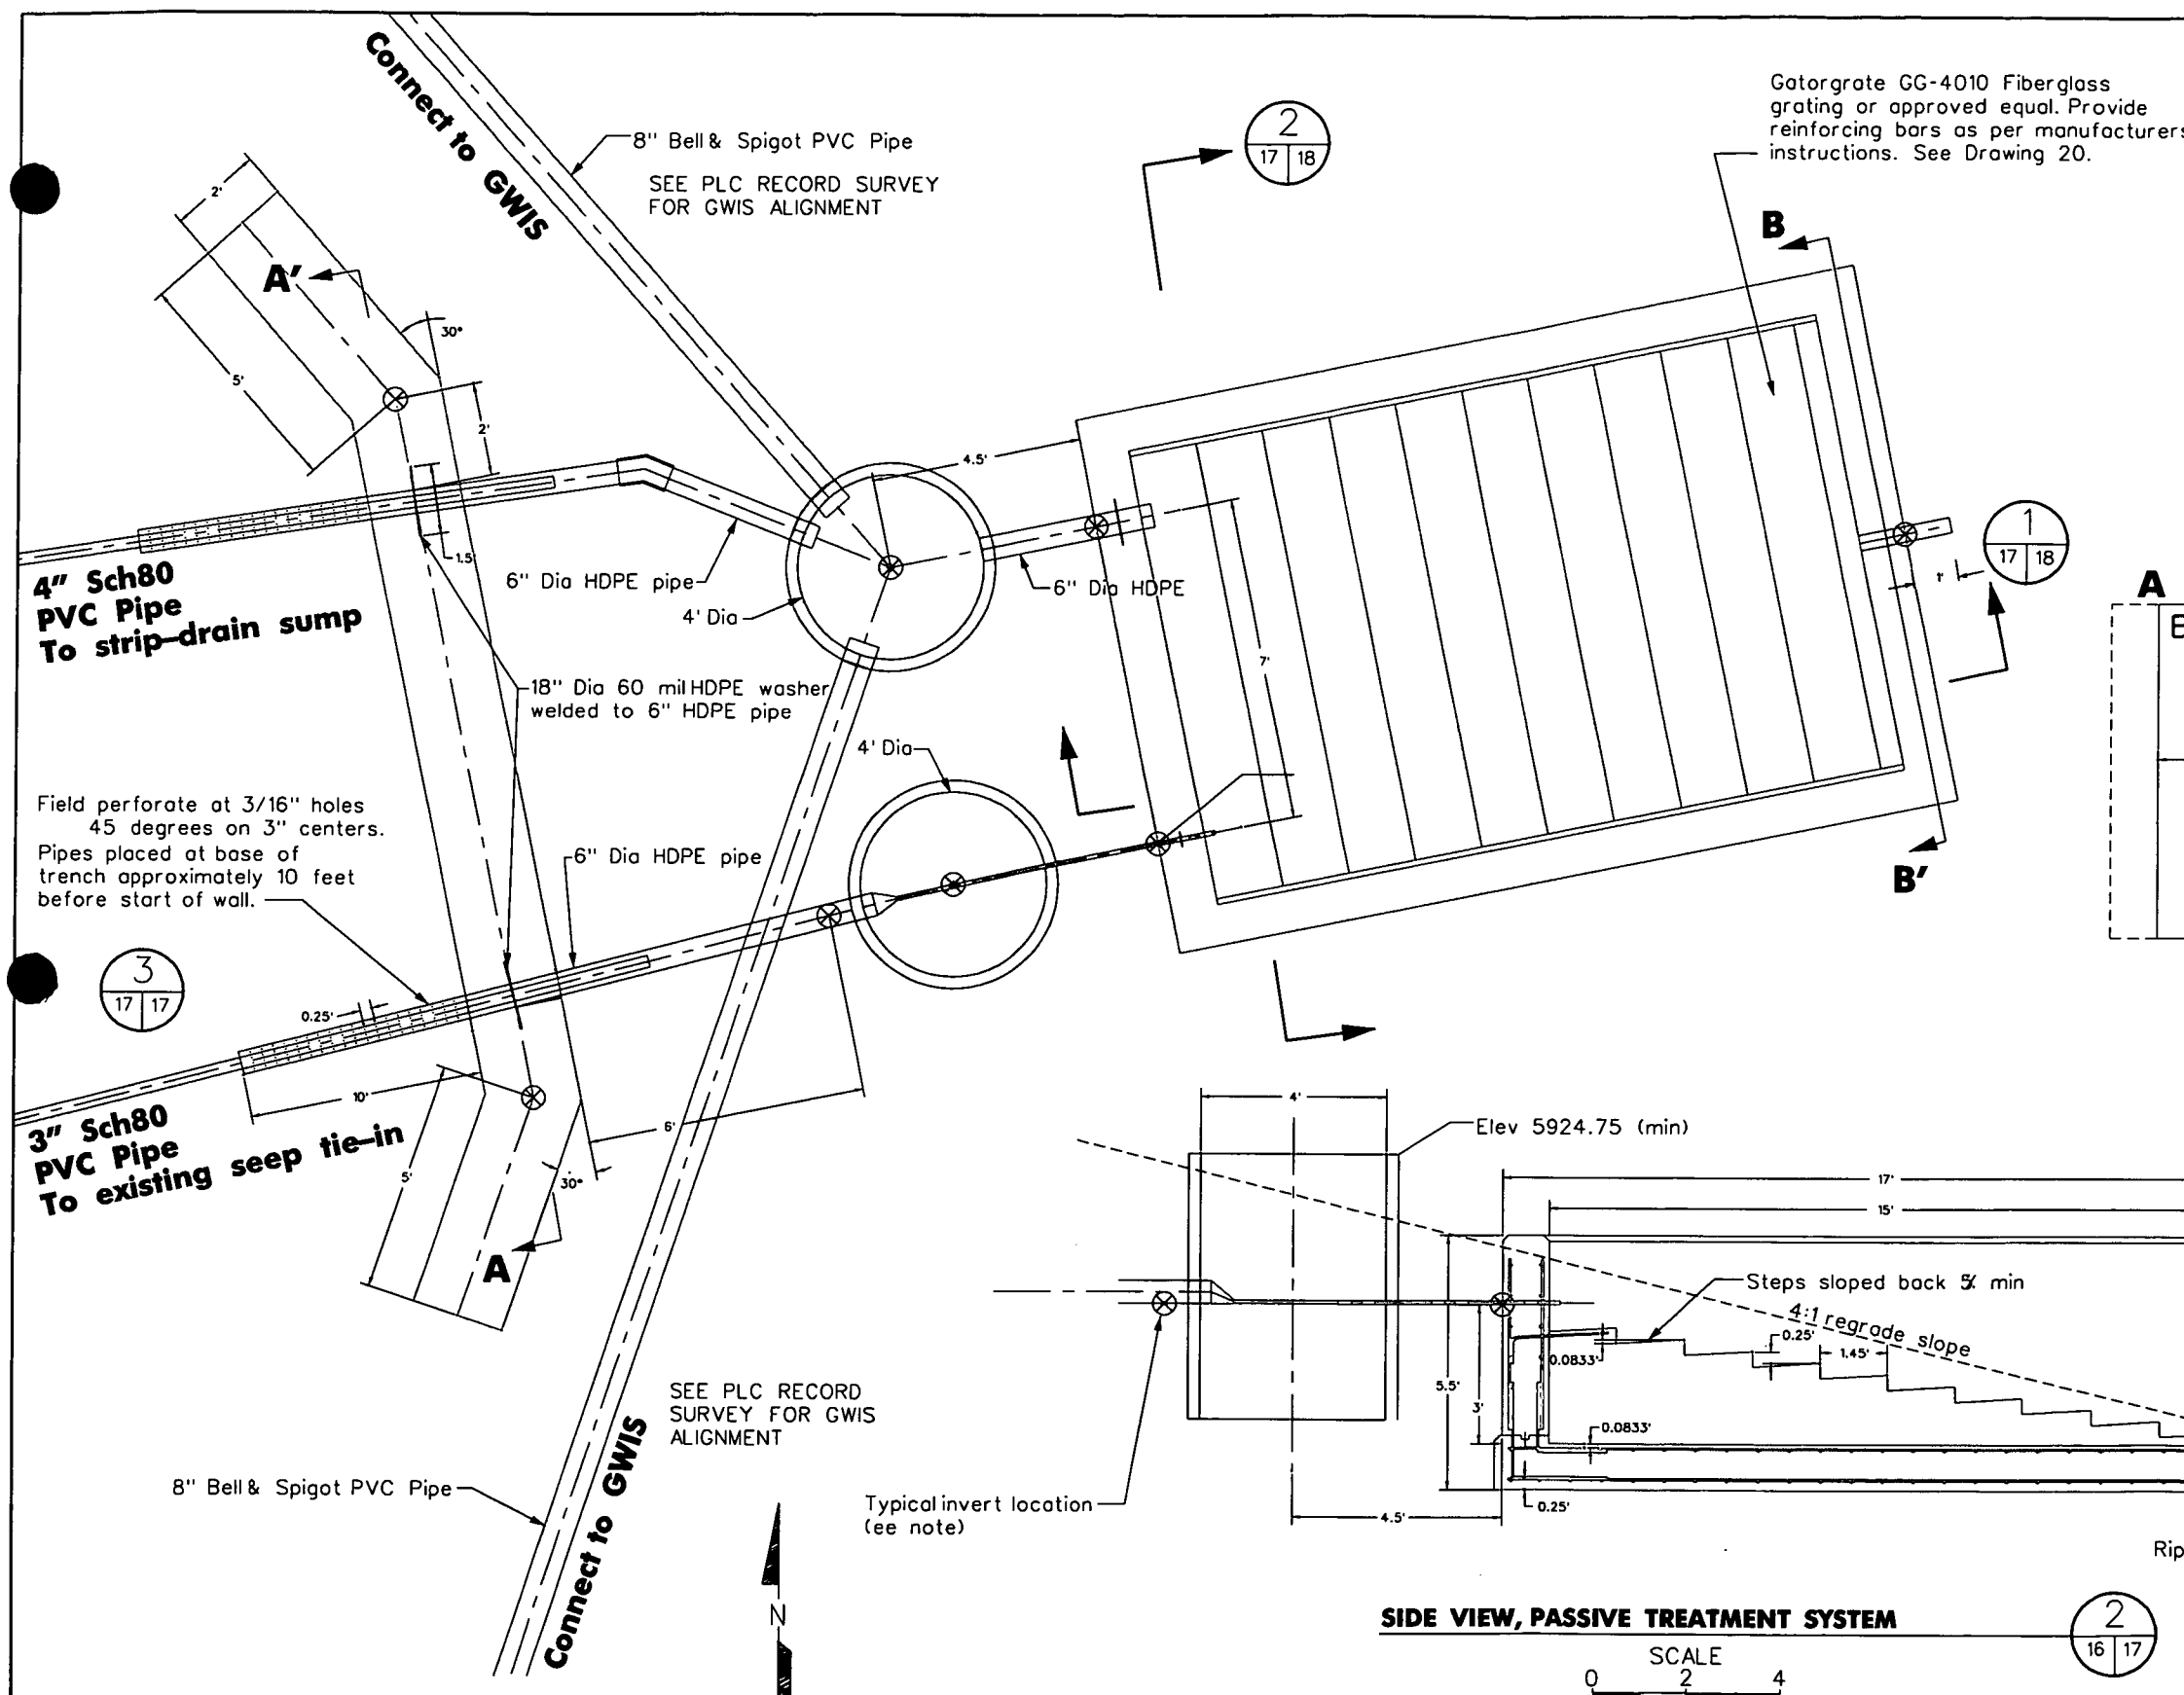
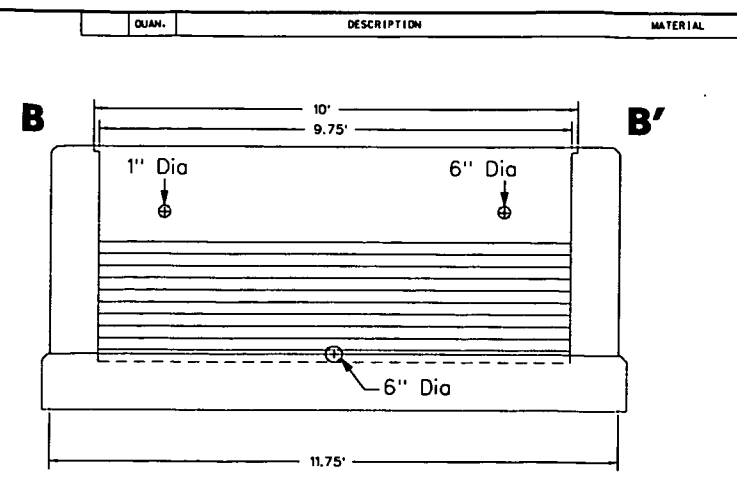
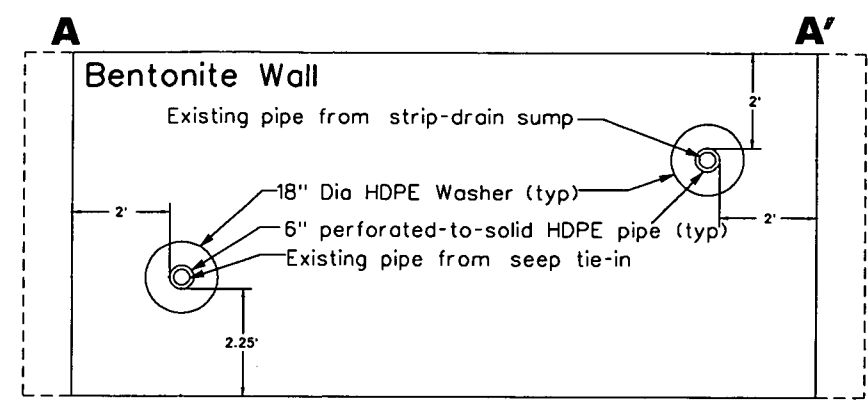
1.	TOLERANCES	<div>NEW SEEP PASSIVE TREATMENT SYSTEM LAYOUT</div> <div>PRESENT LANDFILL ACCELERATED ACTION AS-BUILT</div>												
2.	FRAC. :											DESIGNED BY R. THOMPSON	RD	8/8/04

Note:  
CETCO Pure Gold bentonite crumbles or chips (or equivalent) used. Bentonite was placed in 6" lifts. Each lift was hydrated with 1 gallon water to 20 lbs bentonite. 15 minutes hydration time was allowed before next lift.

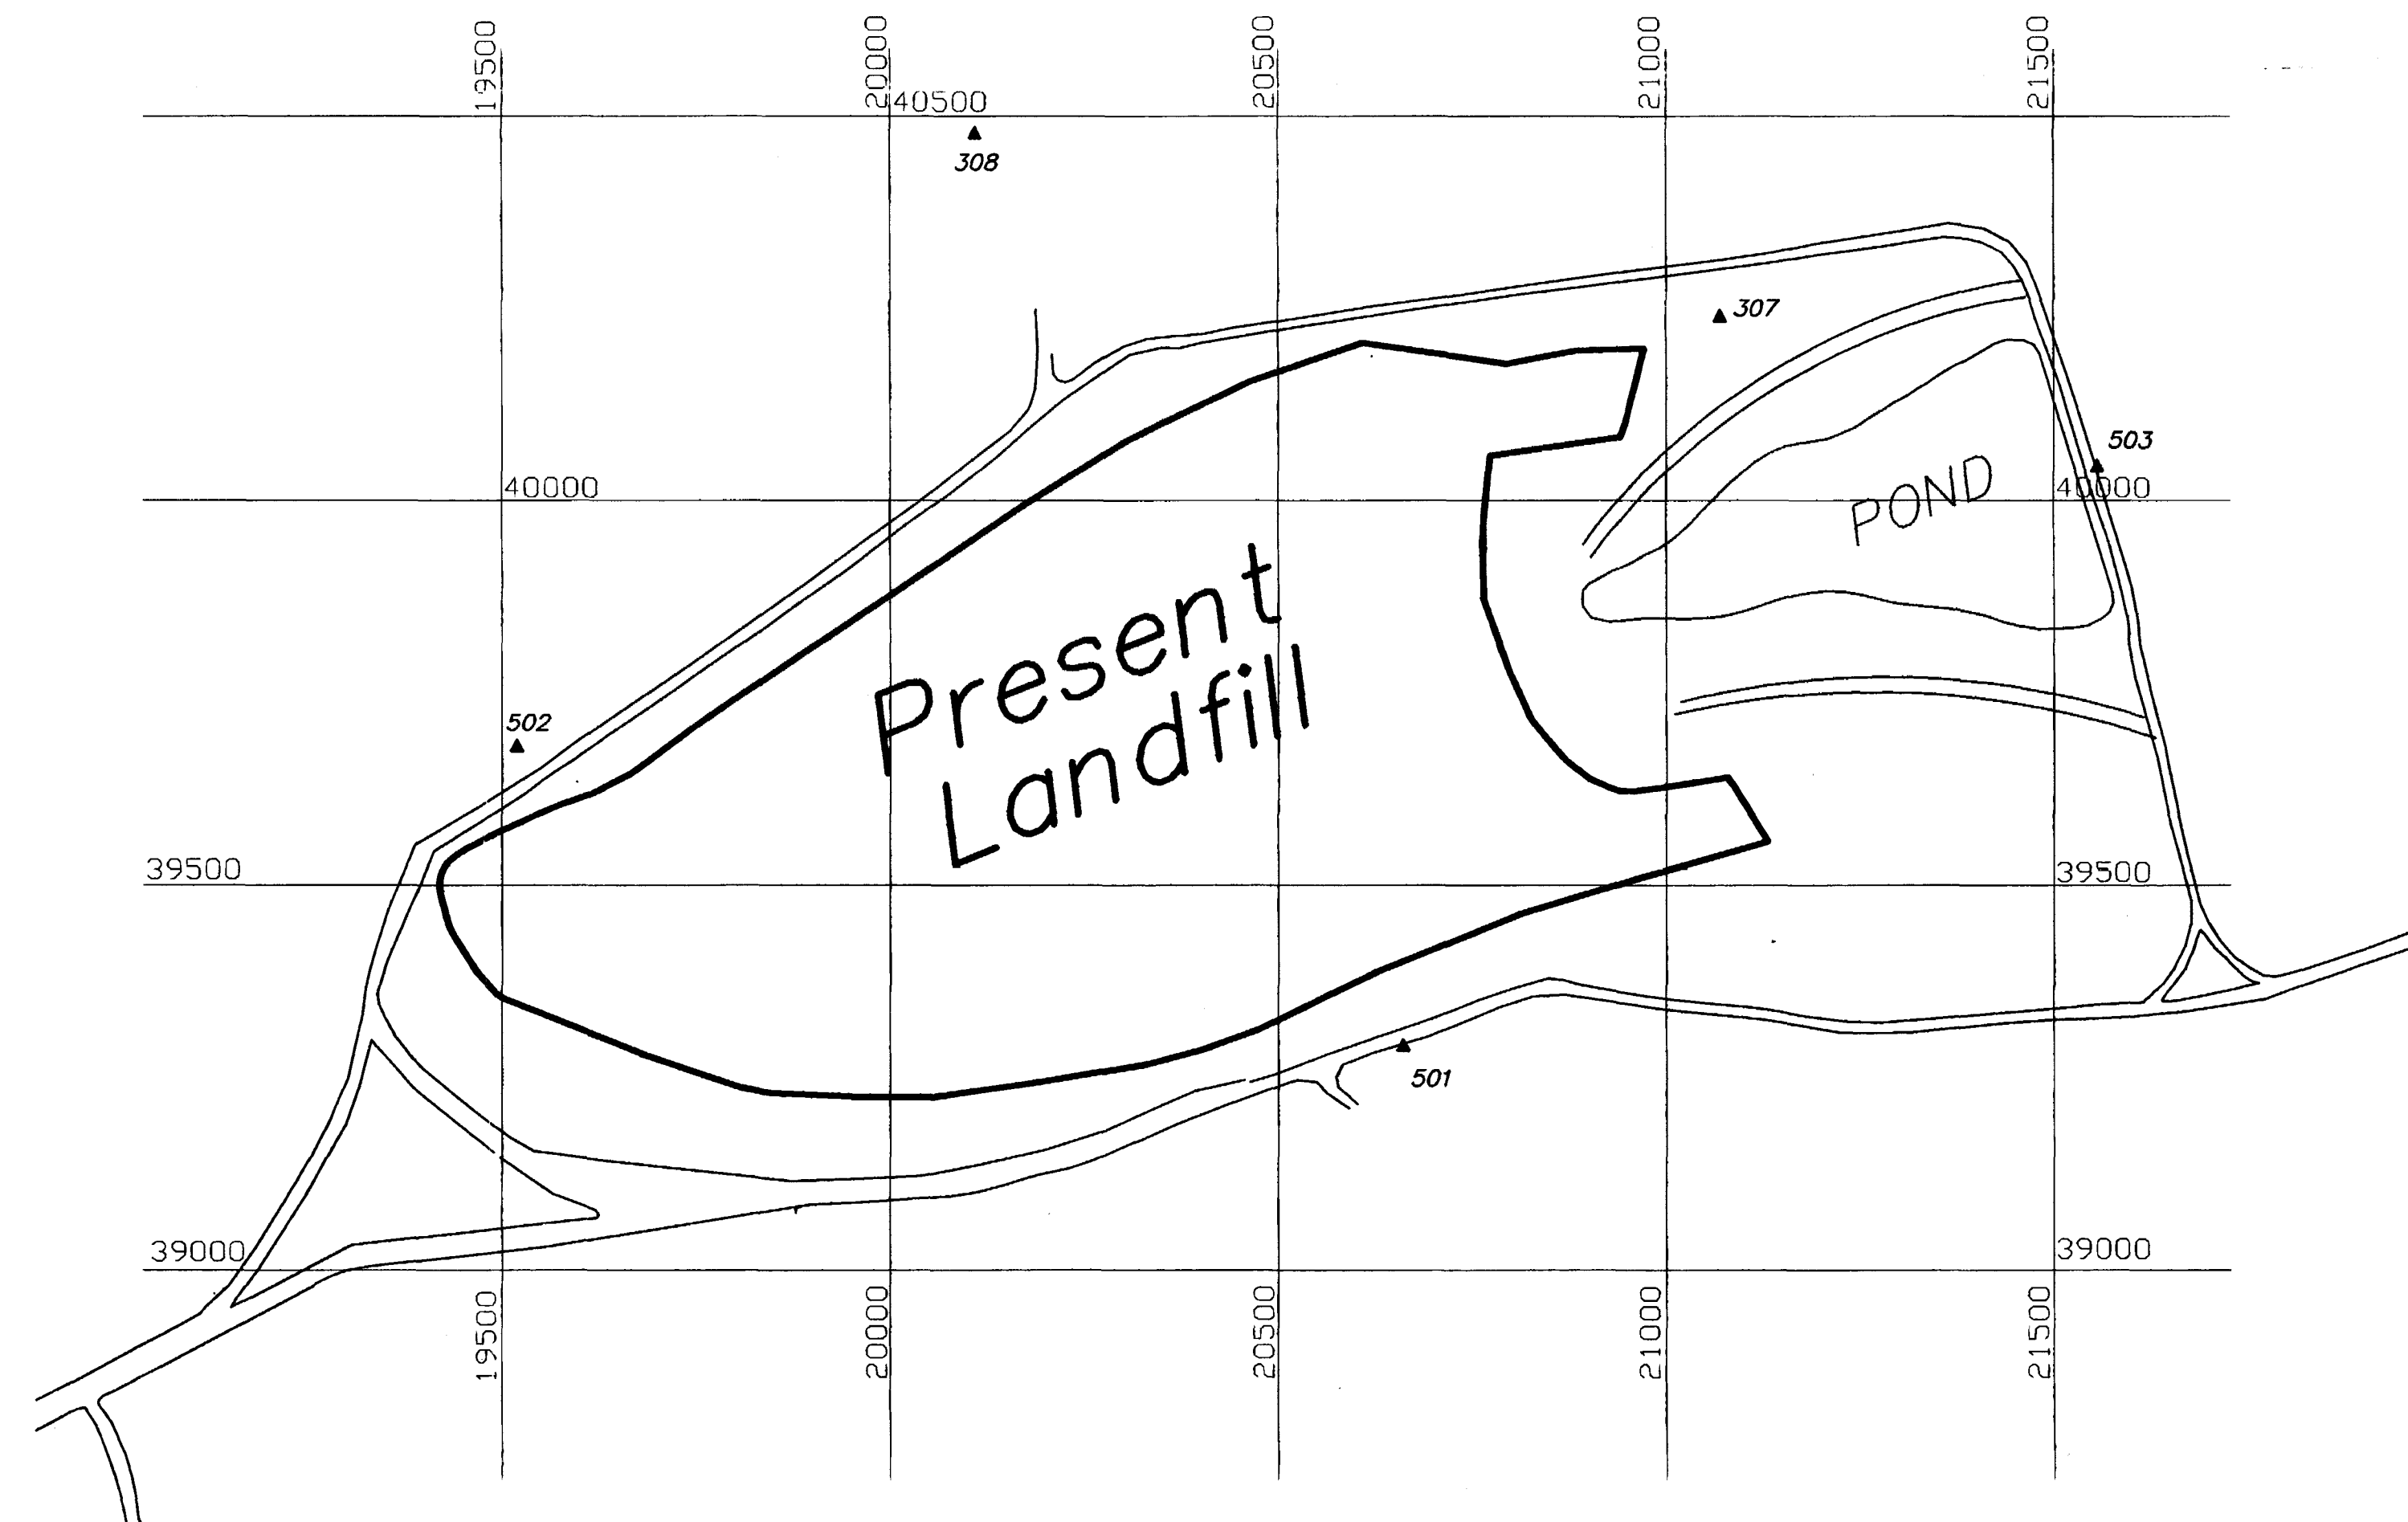
SHEET 2 OF 3---TOPOGRAPHIC ASBUILT (fullfills specifications sections 1.02a-3,6,9,10,11&12)  
-INCLUDES ANCHOR TRENCH, POND SEDIMENT PLACEMENT,  
SOFTSPOT LOCATION AND GAS VENT SYSTEM

PROJECT CONTROL POINTS

POINT	NORTH	EAST	ELEVATION	DESCRIPTION
307	40239.02	21069.24	5961.86	1.5" ALUM CAP
308	40478.50	20108.70	5986.15	1.5" ALUM CAP
501	39289.78	20658.87	5974.00	SET #4 REBAR
502	39678.87	19517.26	5992.16	SET #4 REBAR
503	40043.79	21556.16	5927.01	SET #4 REBAR

ALL NORTHING AND EASTINGS ARE IN ROCKY FLATS COORDINATE SYSTEM
